Chapter 22

Interior Polychromy and Wall Paintings in Khmer Brick Temples of the 9th and 10th Century in Cambodia

Susanne Runkel, Hans Leisen, Esther von Plehwe-Leisen and Robert Fuchs

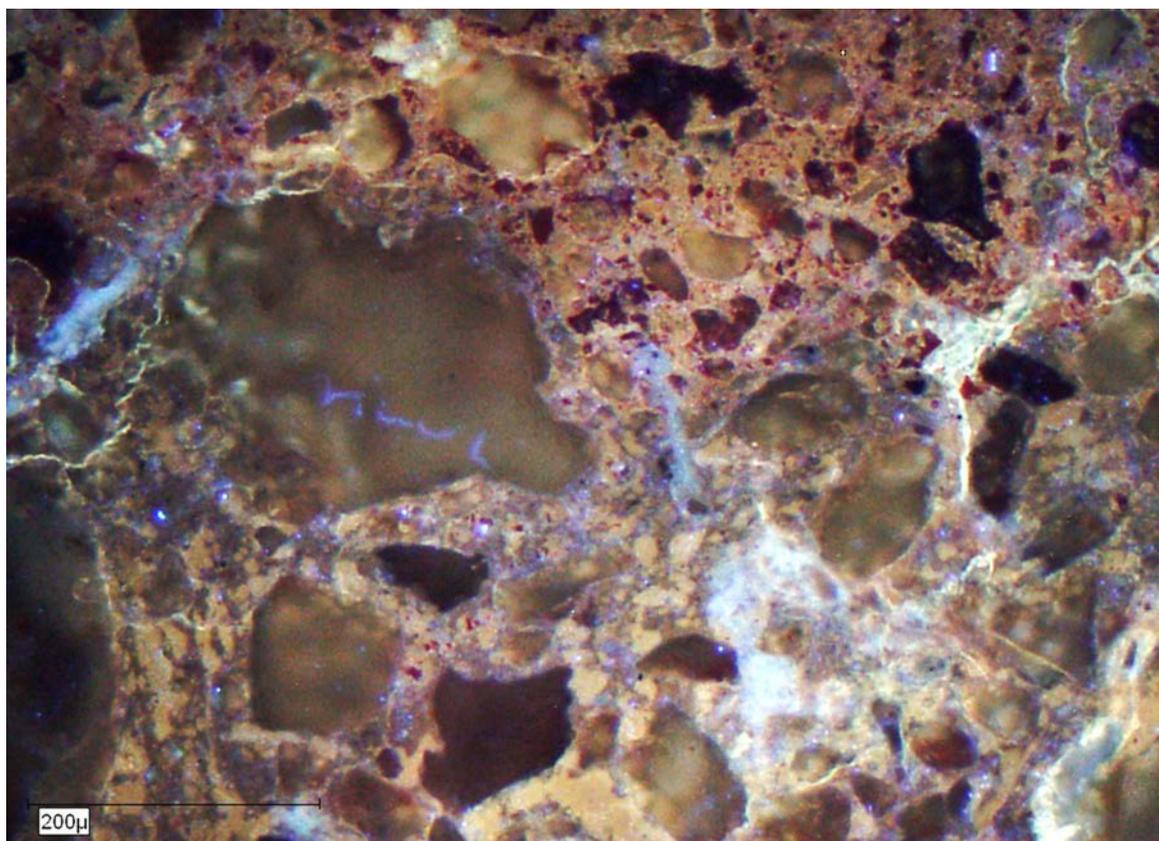
Fig. 22.2: Fluorescence photograph (Zeiss Filter set 02) of a cross-section of a sample from Bakong. Below: brown badigeon, above: red paint layer (Photo: S. Runkel).

The sample from Bakong not only shows a striking spectrum, but its cross-section also reveals a specific light yellow-orange fluorescence [Fig. 22.2]. Comparisons to the fluorescence of samples of Urushi, Kauri copal, Manila copal and colophony showed no match. More conclusive results concerning the characterization of the binder can be obtained by pyrolysis-gas chromatography-mass spectrometry (Py-GC-MS) (Simon *et al.* 2001), which has not yet been possible.

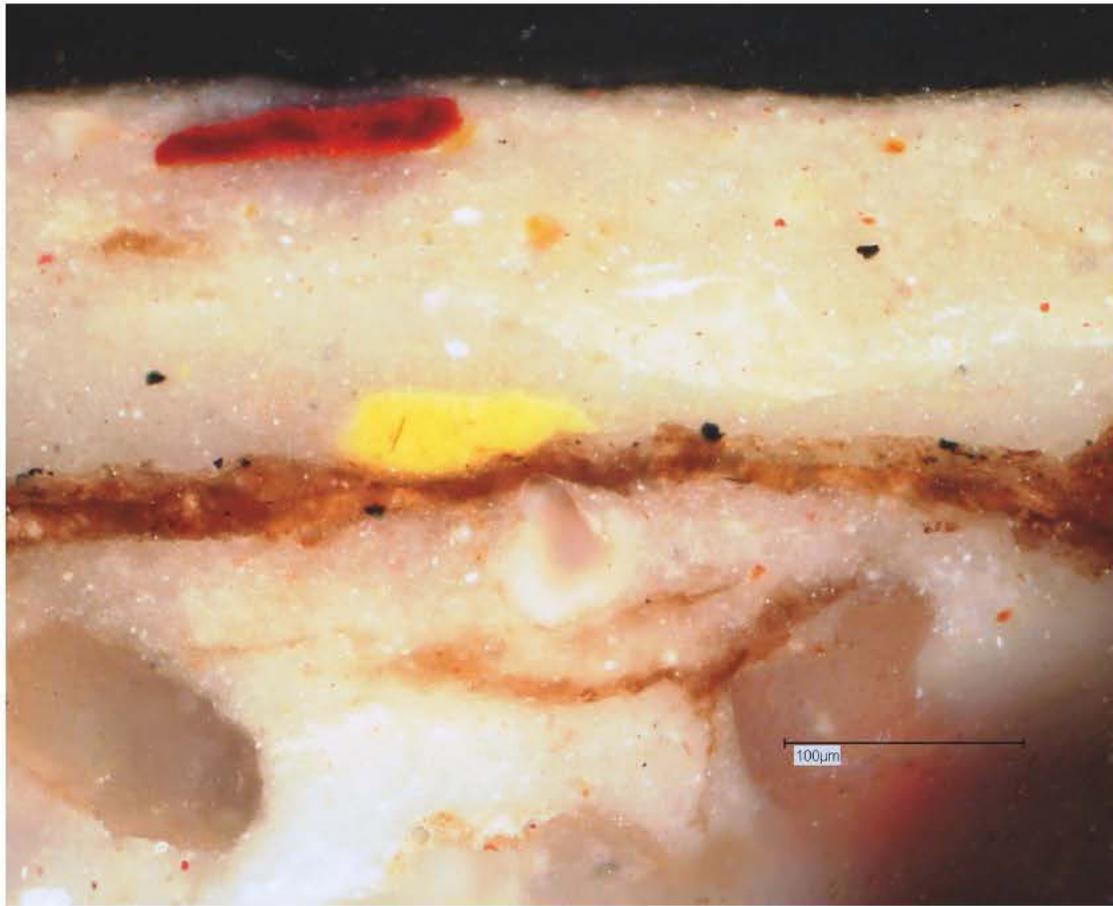
Fig. 22.3: Microscopic picture of a cross-section of a sample from Preah Ko. First and second decoration layers are divided by a brownish layer (Photo: S. Runkel).

In contrast, a thin dark brown layer can be observed between the two ornamental layers [Fig. 22.3]. The EDX analysis of this layer reveals an element composition of mainly phosphorus, along with aluminum, potassium and little iron and magnesium. This layer is interpreted as a deposit of weathering products, salts and dirt. The first ornamental decoration must have been exposed for some time before the repainting was carried out.

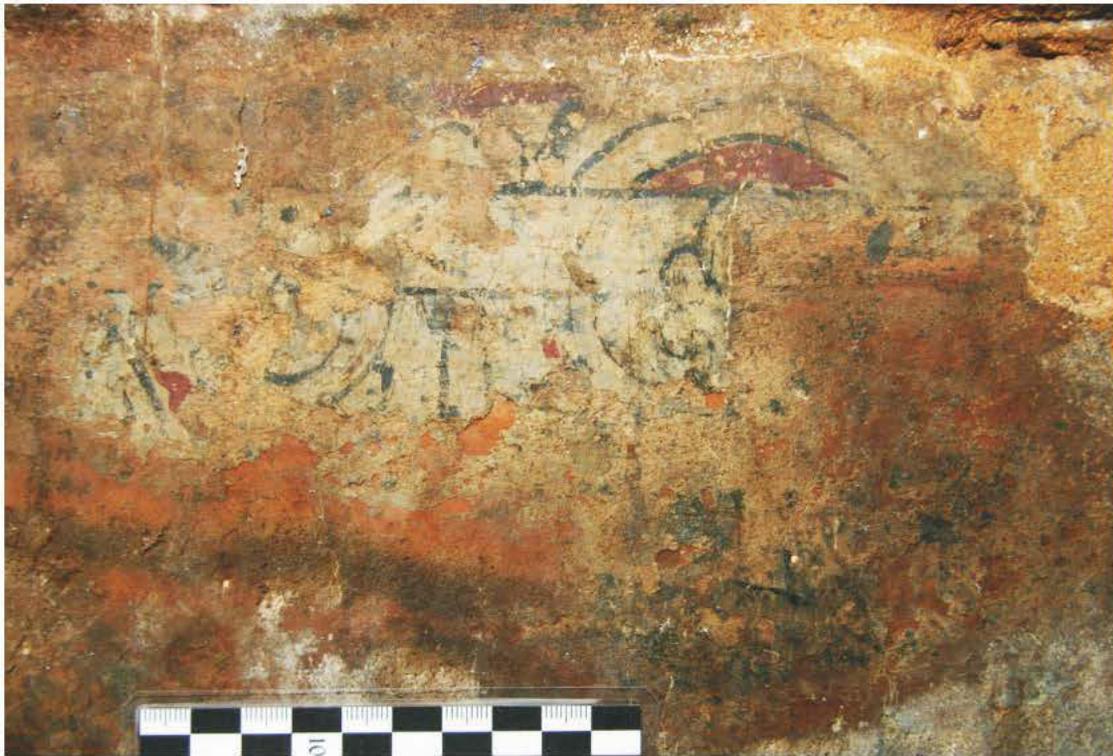
Fig. 22.4: Wall surface showing the stratigraphy of three paint layers in Preah Ko — central-west tower (south wall). Orange paint layer, light paint layer with coarse surface and on top the last light paint layer with black ornaments and red accentuation (Photo: S. Runkel).

The last decoration is much smoother than the other two layers and is thus optically very well distinguishable [Fig. 22.4]. The bright white base coat consists of a white matrix with finely dispersed yellow pigments. On this light background, the black outlines of the tendril ornament were applied and then accentuated in red. The red paint sometimes covers the black paint strokes. Brushwork is visible in some areas and this decorative ornament is not carried out very accurately. This could be due to the distance between the decoration and the contemplator or a lack of artistic skills during the period of execution. Since attention to detail is a characteristic attribute of Khmer art, the last decoration phase might be dated as post-Angkorian, which is the only indication for an age determination.

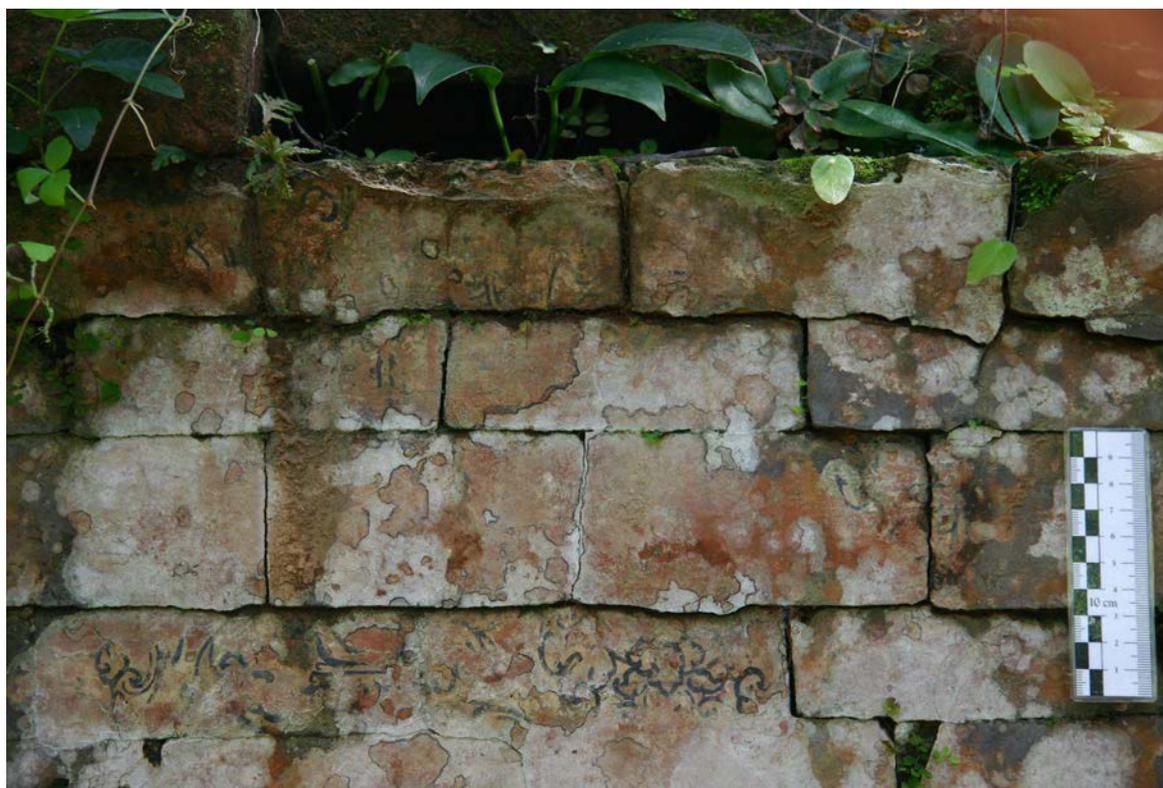
Fig. 22.5: Brick wall in Koh Ker — Prasat Thom (central porch, south wall) with ornament: red ground coat with light yellow paint layer and black outlines (Photo: S. Runkel).

The base coat of the entire brick wall is executed in a thin layer of a brownish-red badigeon. Fragments of a horizontal border with ornaments in black on a white background are preserved. They reach from the cornice to 27cm below on the south wall [Fig. 22.5]. With regard to the decoration of Preah Ko and Prasat Neang Khmau, these fragments are explained as circumferential ornamental borders. However, few traces of this ornament in comparable areas support this hypothesis.

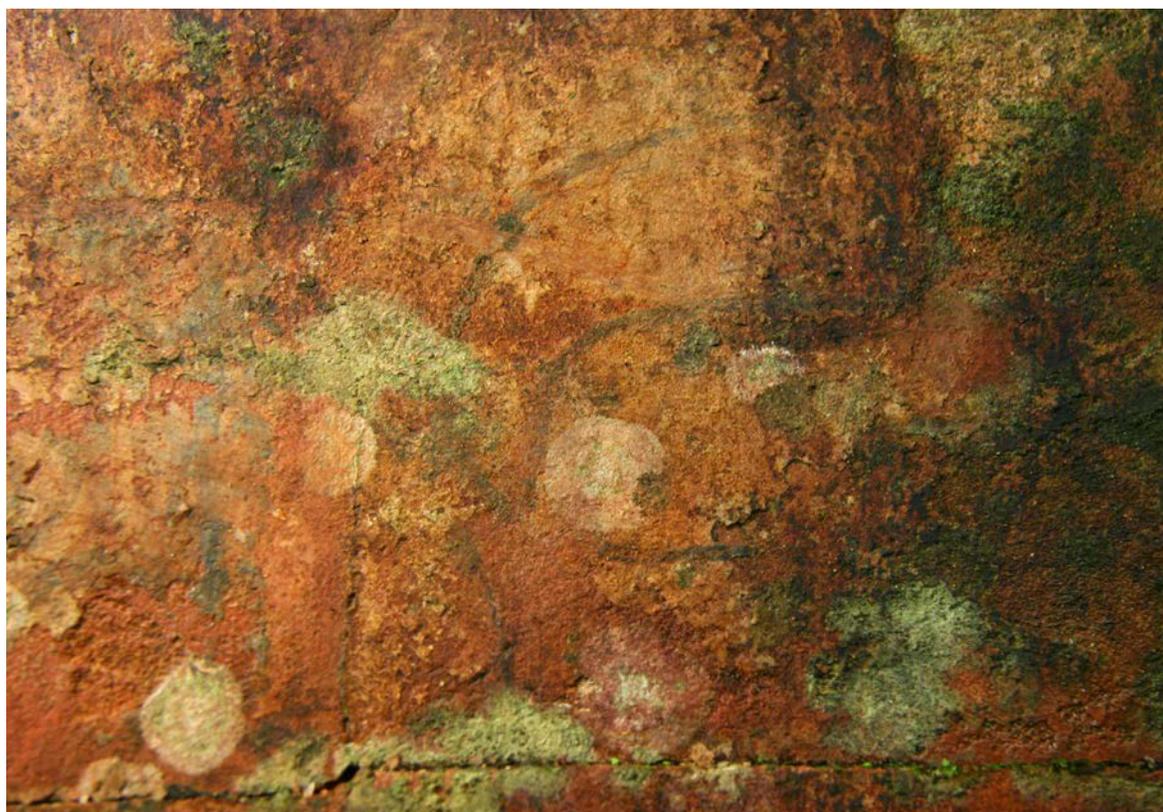
Fig. 22.6: Depiction of a head in Koh Ker — Prasat Thom (south wall) (Photo: S. Runkel).

At the centre of the south wall, traces of figurative paint, like eyes, ears, a headdress and a hand can be found [Fig. 22.6]. These outlines are depicted in brown on a bright background. It is possible that the figures have been painted with a bright whitish color and were accentuated with the dark outlines afterwards. There are other outlines in black or red that probably depict garments.

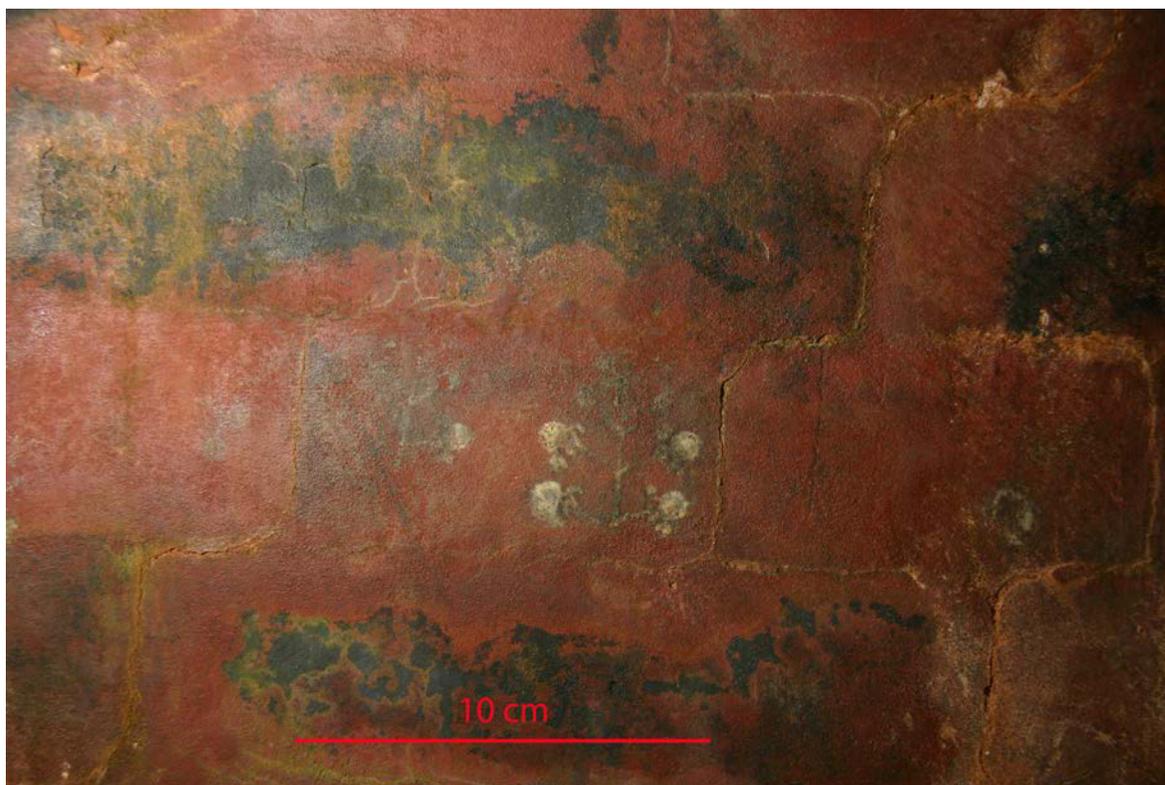
Fig. 22.7: White flowers on red decorated walls in Koh Ker — Prasat Thom (Photo: S. Runkel).

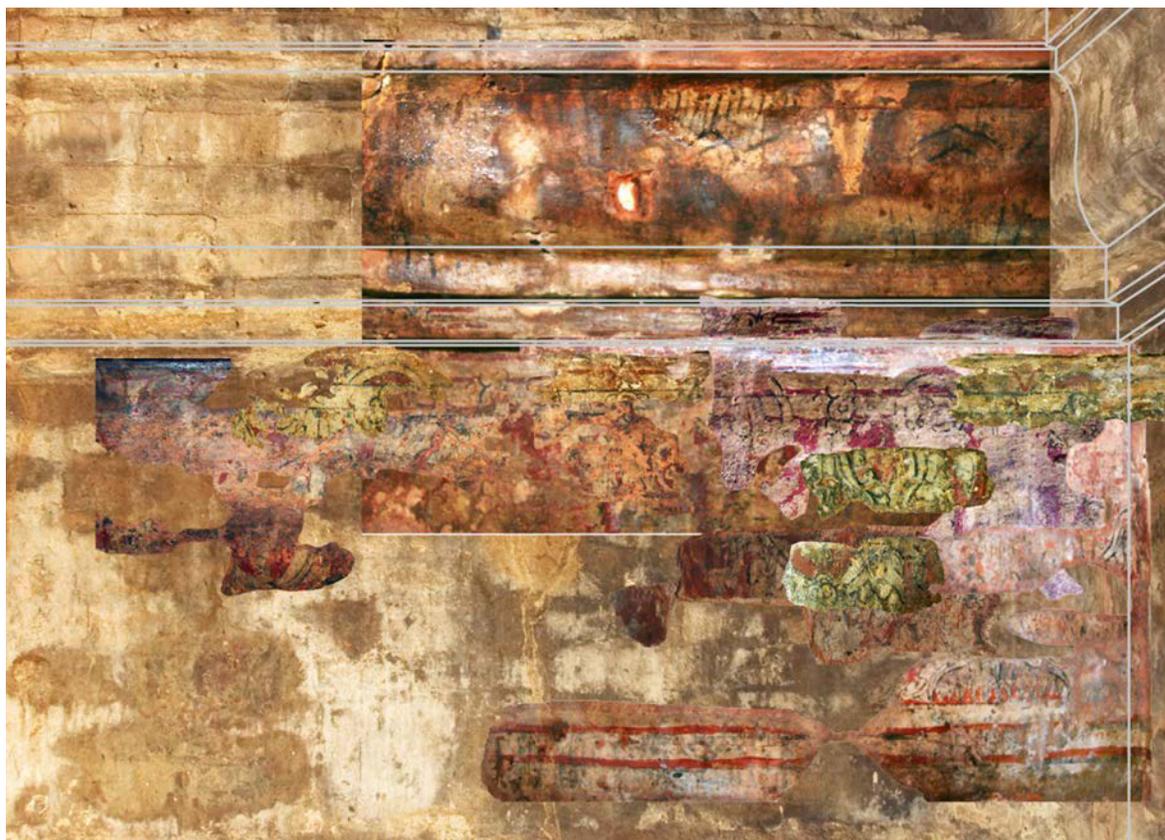
Fig. 22.8: Mosaic of the remains of decorative paint in the central west tower of Preah Ko (Photo: S. Runkel).

closer together horizontally [Fig. 22.8]. The sequence in the pattern repeat was not always implemented regularly. As the distances vary, some of the ornament fragments could only be assigned after a rough sketch of the ornament rapport to add further details. The pattern of the outer decoration was consulted at this point [Fig. 22.9].

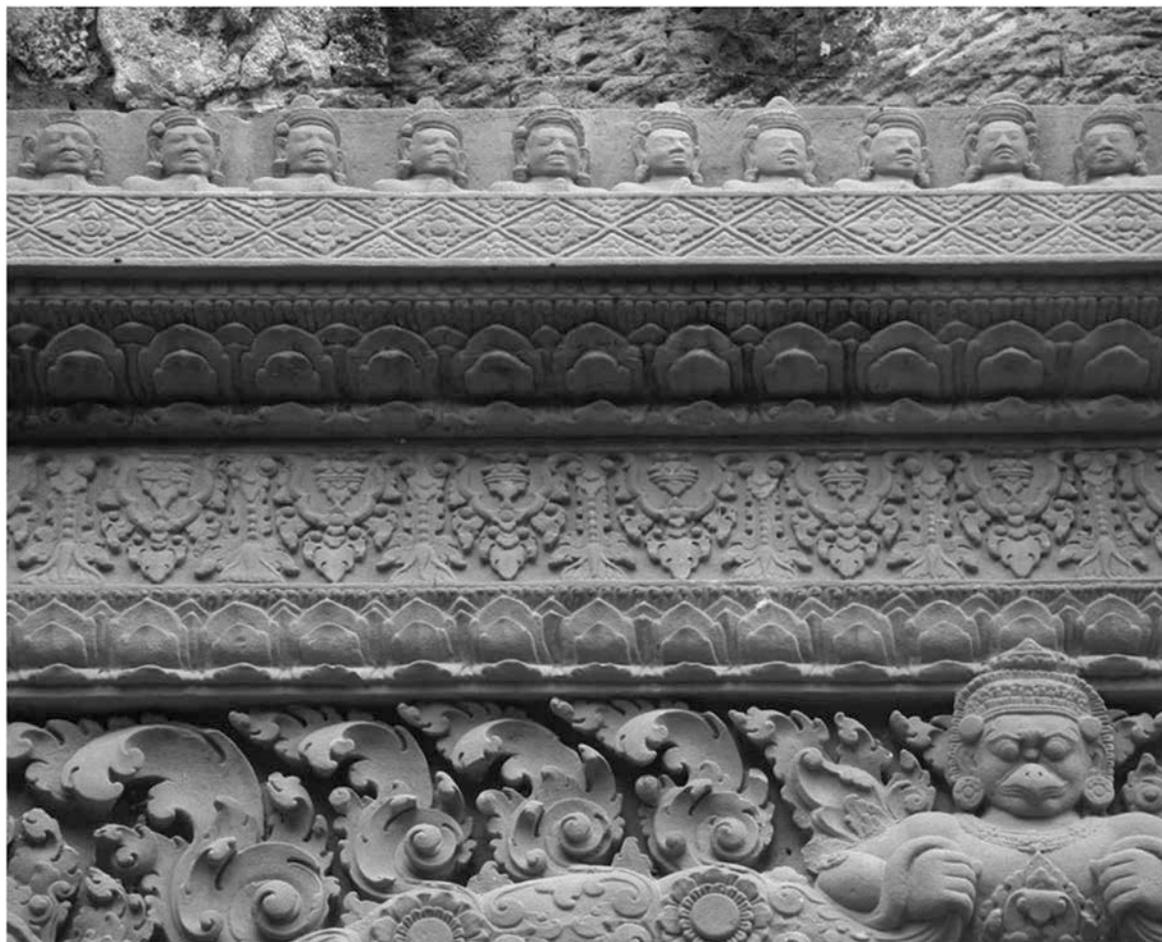
Fig. 22.9: Ornament “3-part curve and lotus” framed by lotus leaves in Preah Ko — south (pediment) of the central-east tower (Photo: S. Runkel).

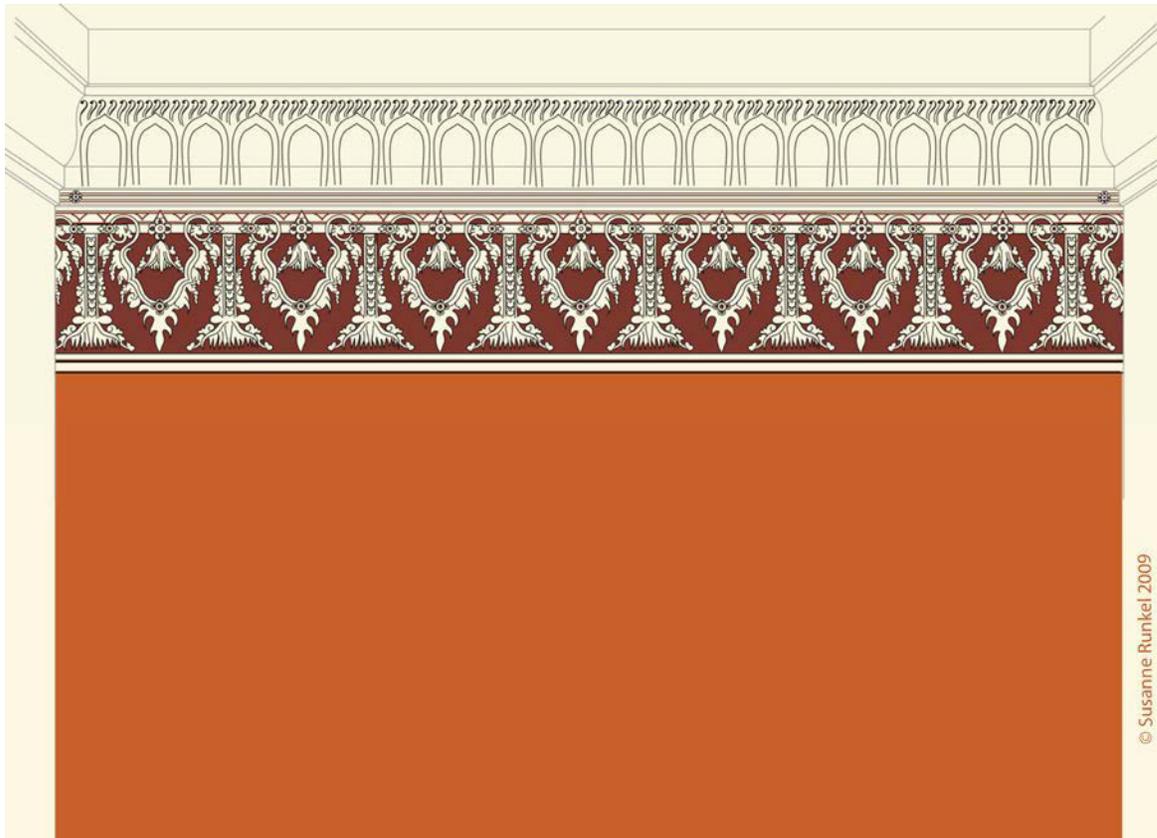
Fig. 22.10: Reconstruction of the second interior wall decoration (Preah Ko — central-west tower) (Reconstruction: S. Runkel).

The patterns of the second decorative painting of Preah Ko [Fig. 22.10] and the painting of a minor tower of Prasat Thom were digitally reconstructed. Both decorations are tendril ornaments that are suspended from a horizontal band alternating with open lotus flower and leaves around a rootstock. Additionally, Preah Ko shows evidence of a painted cornice with lotus leaves.
